REPORT DOCUMENTATION PAGE		READ INSTRUCTIONS BEFORE COMPLETING FORM
1. REPORT NUMBER	2. GOVT ACCESSION NO. AD-A108	3. RECIPIENT'S CATALOG NUMBER 474
4. TITLE (and Subtitle) National Program of Inspection of Non-Federal Dams, Tennessee. Grand Valley Dam No. 2 (Inventory Number TN 06925) near Hickory Valley, TN, Hardeman County, TN, Hatchie River Basin		5. TYPE OF REPORT & PERIOD COVERED Phase 1 Investigation Report

Furnished herewith is the Phase I Investigation Report on Grand Valley Dam No. 2 near Hickory Valley, Tennessee. The report was prepared under the authority and provisions of PL 92-367, the National Dam Inspection Act, dated 8 August 1972.

PHASE I INSPECTION
GRAND VALLEY DAM NO. 2
HARDEMAN COUNTY, TENNESSEE

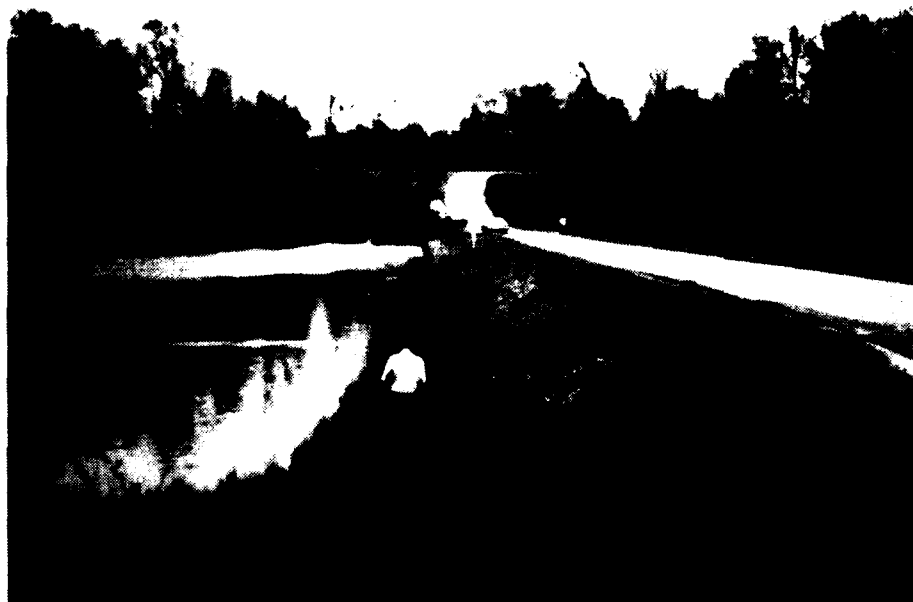
Abutments - There was some erosion noted along the contact of the embankment with the abutment in the form of gullies at both ends of the dam. Also, a good bit of sand has eroded out of a gulley that parallels the road at the left abutment.

1. Upstream slope and top of Grand Valley Dam No. 2. Note erosion at road side ditch in left abutment.

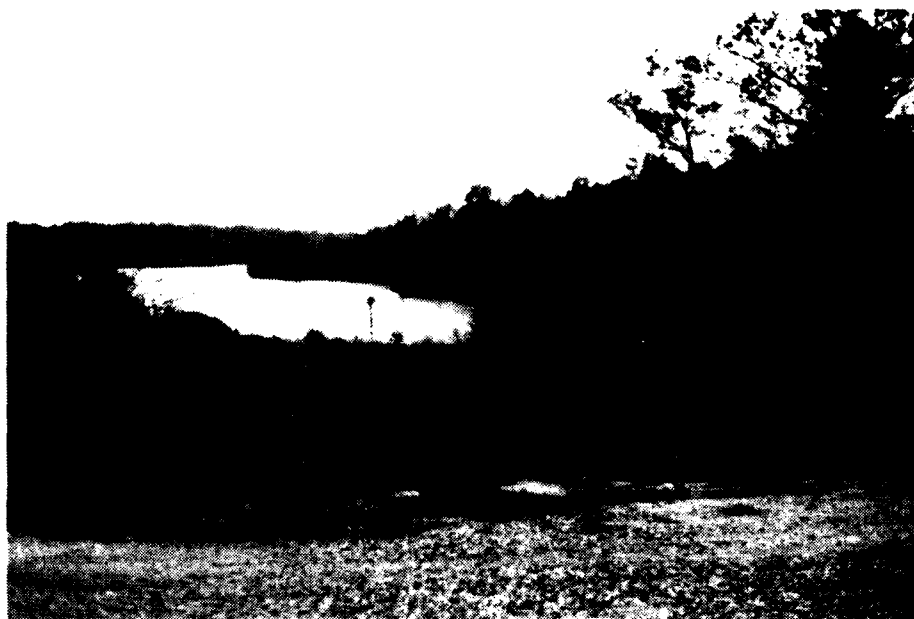
Emergency Spillway - There is approximately two feet of fall along the crest from the right abutment to the left abutment. The emergency spillway was originally designed in the right abutment. Flow through this emergency spillway was effectively cut off by the building of the road fill and consequently the low portion of the crest at the left abutment presently acts as the emergency spillway. Should flow occur over the dam at this point, the increased velocity of the water crossing the pavement and down the backslope would cause severe erosion of the backslope and possible failure of the structure.

5. Emergency spillway cut into right abutment of Grand Valley Dam No. 2.
Note road fill across control section.

EMERGENCY SPILLWAY. There is approximately two feet of fall along the crest from the right abutment to the left abutment. The emergency spillway was designed in the right abutment. The flow through the emergency spillway was effectively cut off by the building of the road and consequently the low portion at the crest at the left abutment now acts as the emergency spillway. Should flow occur over the dam at this point, the increased velocity of the water across the pavement and over the backslope would cause severe erosion of the backslope and possibly failure of the structure.

Recommendations. The road should be regraded or else a culvert pipe should be jacked under the road, in order to permit the emergency spillway to act as intended. The seepage at the foot of the left abutment is not serious but should be watched, particularly that occurring at the contact between the service spillway and the adjacent fill. Many dam failures have been started by seepage at this contact. The seepage should be measured about every 3 months by collecting it in a container of known volume. Signs of soil color or suspended matter in the seepage water should be noted particularly. If the rate of seepage increases significantly or if the leakage shows suspended solids, engineering assistance should be secured immediately.

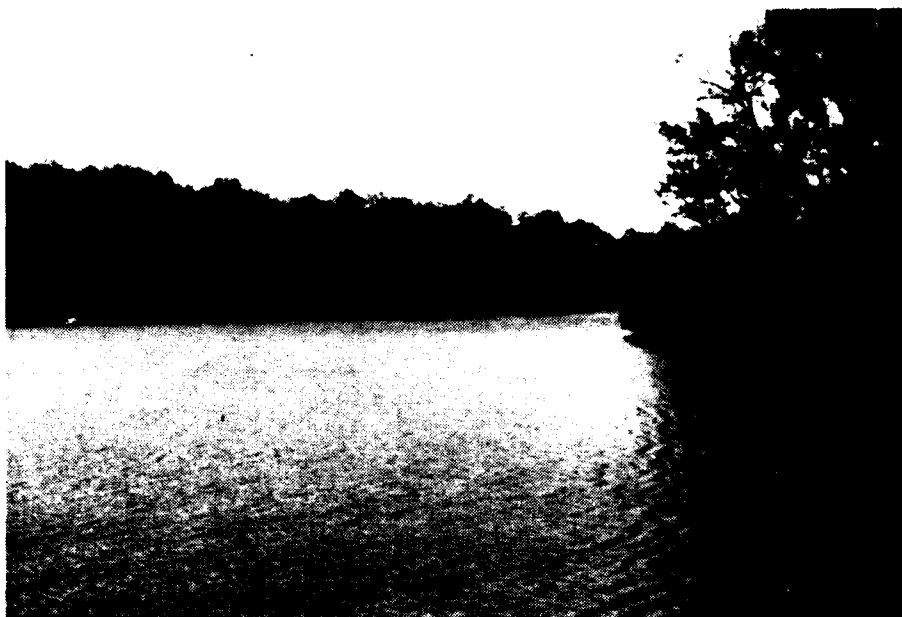
7. Impoundment above Grand Valley Dam No. 2.
